**Flood Control Project Maintenance
Levee Inspections**

Fall 2015 Levee Maintenance Deficiency Summary Report

Sacramento River Basin

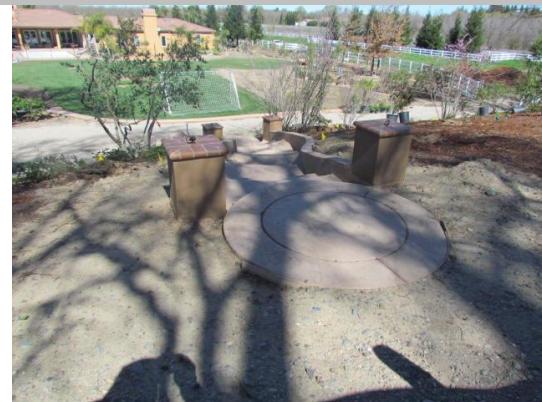
Photo 2 of 2 : FA_2015_RD0999_236_196_20150914_00121.jpg

Looking north at concrete stairs on landward slope.

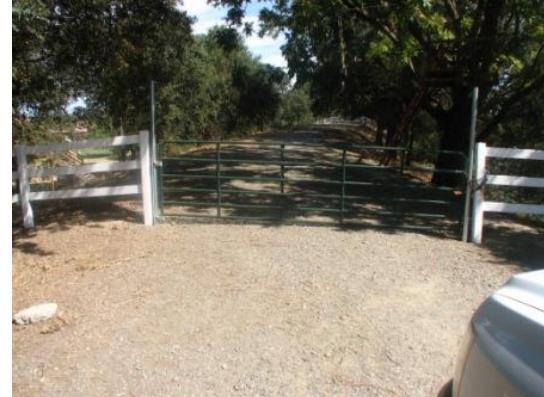
Photo 1 of 2 : FA_2015_RD0999_236_103_20150914_00084.jpg

LM Start	8.59	Rating **	M	Issue No.	103										
LM End	8.59	Issue Type +	En	Location *	CR										
Category	Earthen Levee			GPS Latitude/Longitude											
				Start	End										
Item	Encroachments			38.410332 °	38.410332 °										
				-121.532277 °	-121.532277 °										
DWR ID	DWR_RD0999_05_s_2012_103														
Action/Comments															
Fence

View of fence & gate across levee crown, landside & waterside slope.

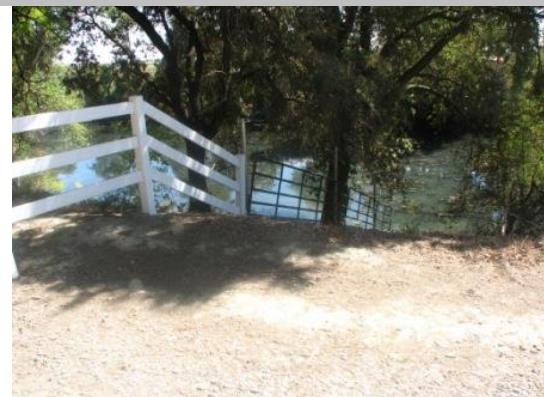
Photo 2 of 2 : FA_2015_RD0999_236_103_20150914_00085.jpg

New unauthorized fence that extend from landside toe to waterside toe.

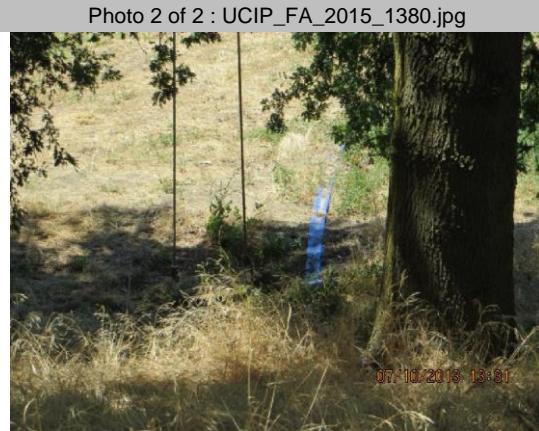
LM Start	8.62	Rating **	M	Issue No.	238																			
LM End	8.62	Issue Type +	En	Location *	LS																			
Category				GPS Latitude/Longitude																				
				Start	End																			
Item				38.410531 °	38.410531 °																			
				-121.531785 °	-121.531785 °																			
DWR ID																								
Action/Comments																								
Inspector Comments: FS_ID:16345 DS_ID:23990 EP_NO: N/A FS_HLM: 8.77 Repair Type: Non-Urgent Crossing Status: Found UCIP Comments: Need to determine permit No for crossing or remove it. FIELD_STRUCT_DESC: 3-inch plastic irrigation hose over the levee. Small portable pump on WS toe. FS Date: 07/10/2013

Plastic hose visible on LS toe.

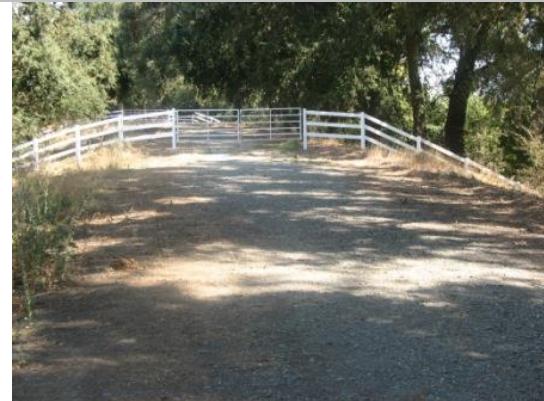
Photo 1 of 1 : FA_2015_RD0999_236_104_20150914_00086.jpg

LM Start	8.63	Rating **	M	Issue No.	104										
LM End	8.63	Issue Type +	En	Location *	CR										
Category	Earthen Levee			GPS Latitude/Longitude											
				Start	End										
Item	Encroachments			38.410617 °	38.410617 °										
				-121.531694 °	-121.531694 °										
DWR ID	DWR_RD0999_05_s_2012_104														
Action/Comments															
Fence

New unauthorized fence and gate that extends from landside toe across levee crown to waterside toe.

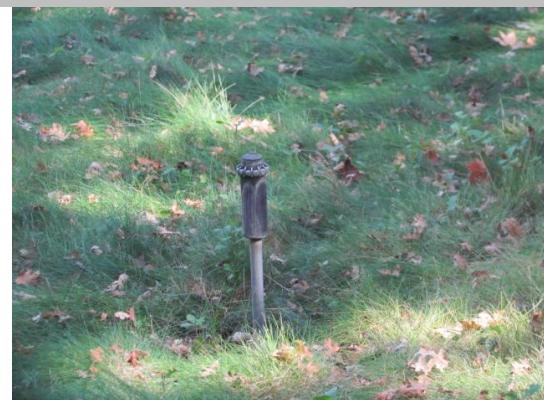
Photo 1 of 1 : FA_2015_RD0999_236_134_20150914_00094.jpg

LM Start	8.73	Rating **	M	Issue No.	134										
LM End	8.82	Issue Type +	En	Location *	LS										
Category	Earthen Levee			GPS Latitude/Longitude											
				Start	End										
Item	Encroachments			38.411577 °	38.412619 °										
				-121.530375 °	-121.529691 °										
DWR ID	DWR_RD0999_05_f_2012_134														
Action/Comments															
Landscape Irrigation Inspector Comments: Sprinklers on landward and waterward shoulder.

Looking at one of several sprinklers on waterward and landward slope.

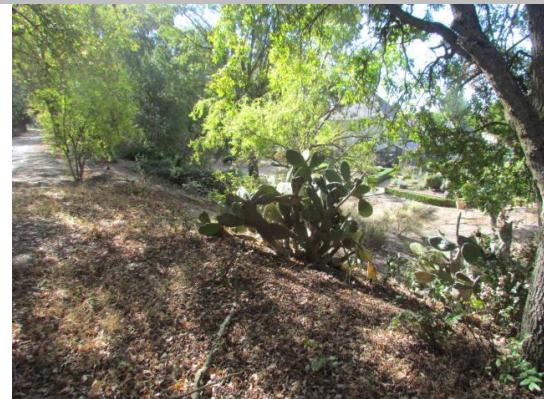
Photo 1 of 1 : FA_2015_RD0999_236_127_20150914_00087.jpg

LM Start	8.90	Rating **	M	Issue No.	127										
LM End	8.92	Issue Type +	En	Location *	LS										
Category	Earthen Levee			GPS Latitude/Longitude											
				Start	End										
Item	Vegetation			38.413780 °	38.414138 °										
				-121.529727 °	-121.529772 °										
DWR ID	DWR_RD0999_05_s_2012_127														
Action/Comments															
Landscaping Inspector Comments: Cactus and other plants and sprinklers on landward slope.

Looking west at cactus and other vegetation on landward slope.

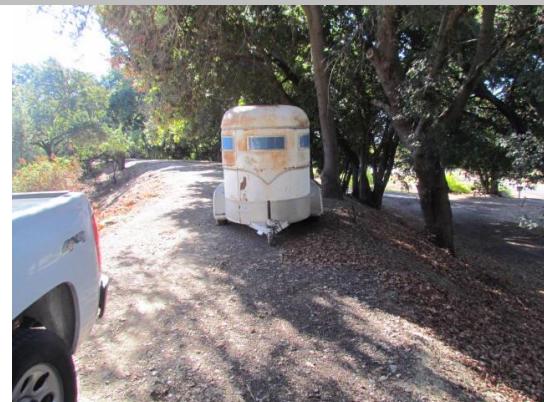
Photo 1 of 1 : FA_2015_RD0999_236_188_20151106_00171.jpg

LM Start	9.03	Rating **	U	Issue No.	188										
LM End	9.03	Issue Type +	En	Location *	LS										
Category	Earthen Levee			GPS Latitude/Longitude											
				Start	End										
Item	Encroachments			38.415578 °	38.415578 °										
				-121.529263 °	-121.529263 °										
DWR ID	DWR_RD0999_05_f_2015_188														
Action/Comments															
Equipment Inspector Comments: Landowner parked horse trailer on levee landward shoulder blocking access to levee.

Looking west at horse trailer blocing access to levee.

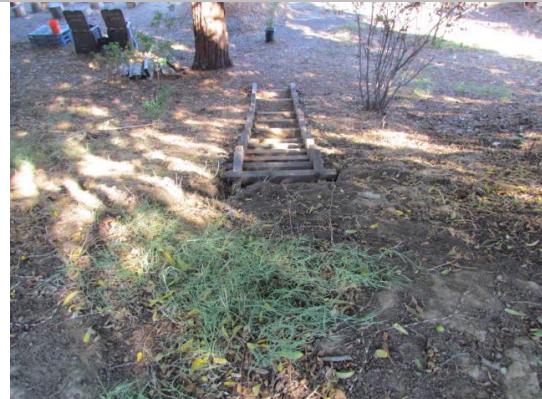
Photo 1 of 1 : FA_2015_RD0999_236_200_20151106_00172.jpg

LM Start	9.14	Rating **	U	Issue No.	200									
LM End	9.14	Issue Type +	En	Location *	LS									
Category	Earthen Levee			GPS Latitude/Longitude										
				Start	End									
Item	Encroachments			38.415787 °	38.415787 °									
				-121.527437 °	-121.527437 °									
DWR ID	DWR_RD0999_05_f_2015_200													
Action/Comments														
Stairway Inspector Comments: Landowner installed stairs on landward slope without permit.

Looking north stairs on landward slope.

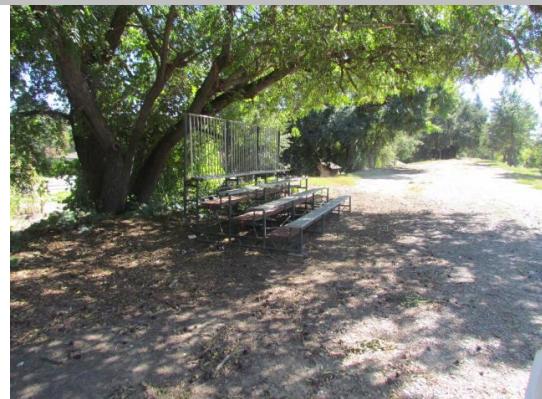
Photo 1 of 1 : FA_2015_RD0999_236_158_20150914_00111.jpg

LM Start	9.15	Rating **	M	Issue No.	158									
LM End	9.15	Issue Type +	En	Location *	LS									
Category	Earthen Levee			GPS Latitude/Longitude										
				Start	End									
Item	Encroachments			38.415709 °	38.415709 °									
				-121.527393 °	-121.527393 °									
DWR ID	DWR_RD0999_05_f_2013_158													
Action/Comments														
Equipment Inspector Comments: Landowner has placed bleacher on landward shoulder.

Looking northeast at bleacher stored on landward shoulder.

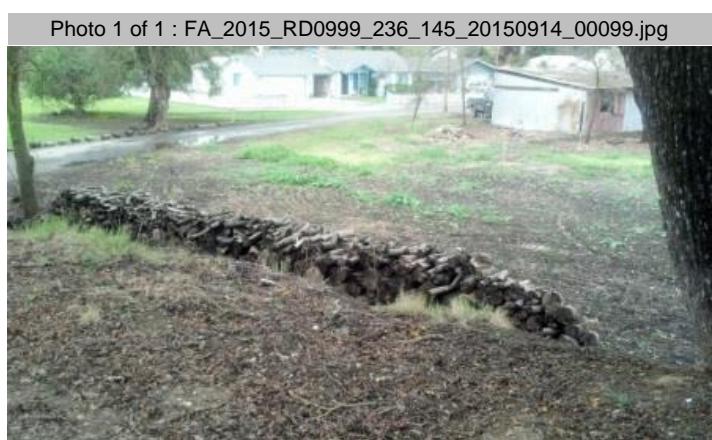
LM Start	9.44	Rating **	M	Issue No.	145		Photo 1 of 1 : FA_2015_RD0999_236_145_20150914_00099.jpg																			
LM End	9.44	Issue Type +	En	Location *	LS																					
Category	Earthen Levee			GPS Latitude/Longitude																						
				Start	End																					
Item	Encroachments			38.413755 °	38.413755 °																					
				-121.523723 °	-121.523723 °																					
DWR ID	DWR_RD0999_05_s_2013_145																									
Action/Comments																										
Firewood Inspector Comments: Firewood stockpile at landward toe.

Looking north at firewood piled at landside toe.
